## Northern Railway

No. 230-Elect/RSO/FZR/14  
Dated: 29.04.2026

### Special-Instructions

#### Subject: Improper UIC Coupler Attachment – Instructions to Running Staff

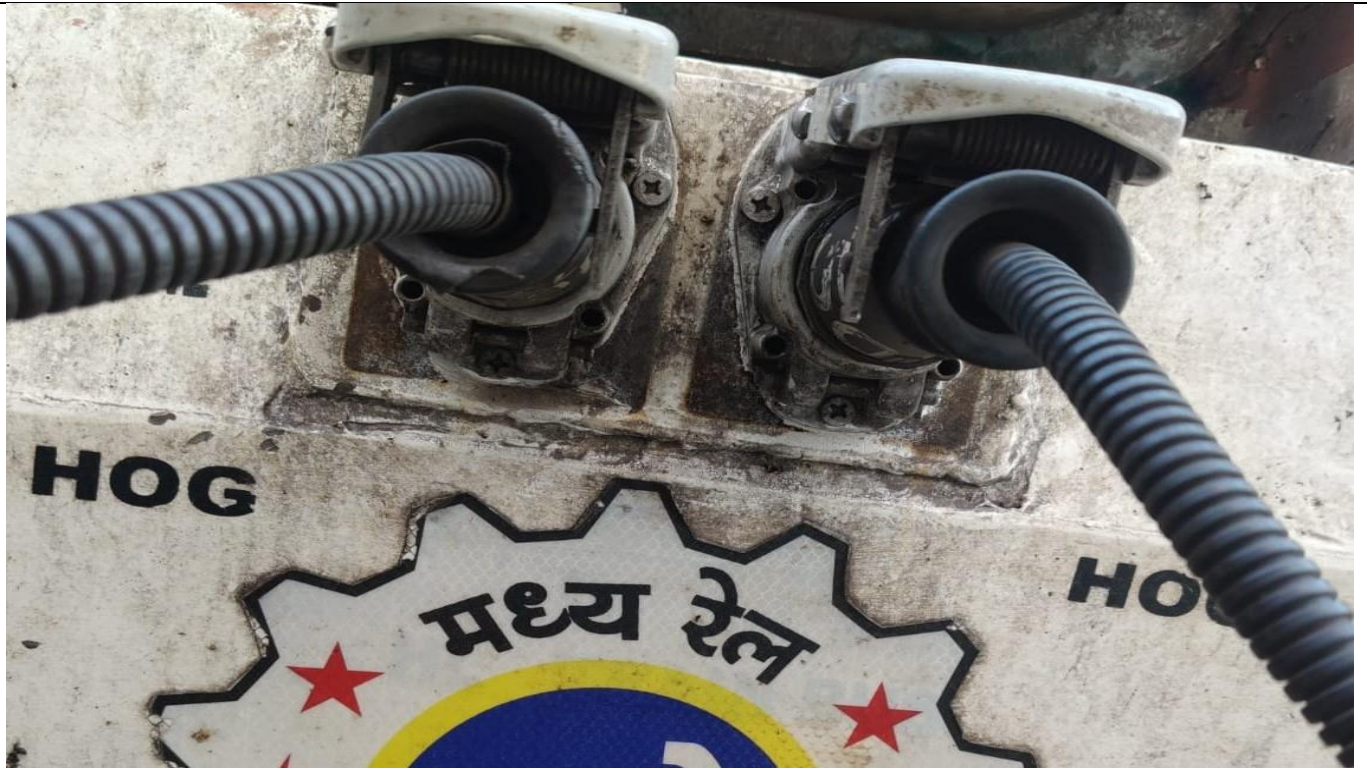
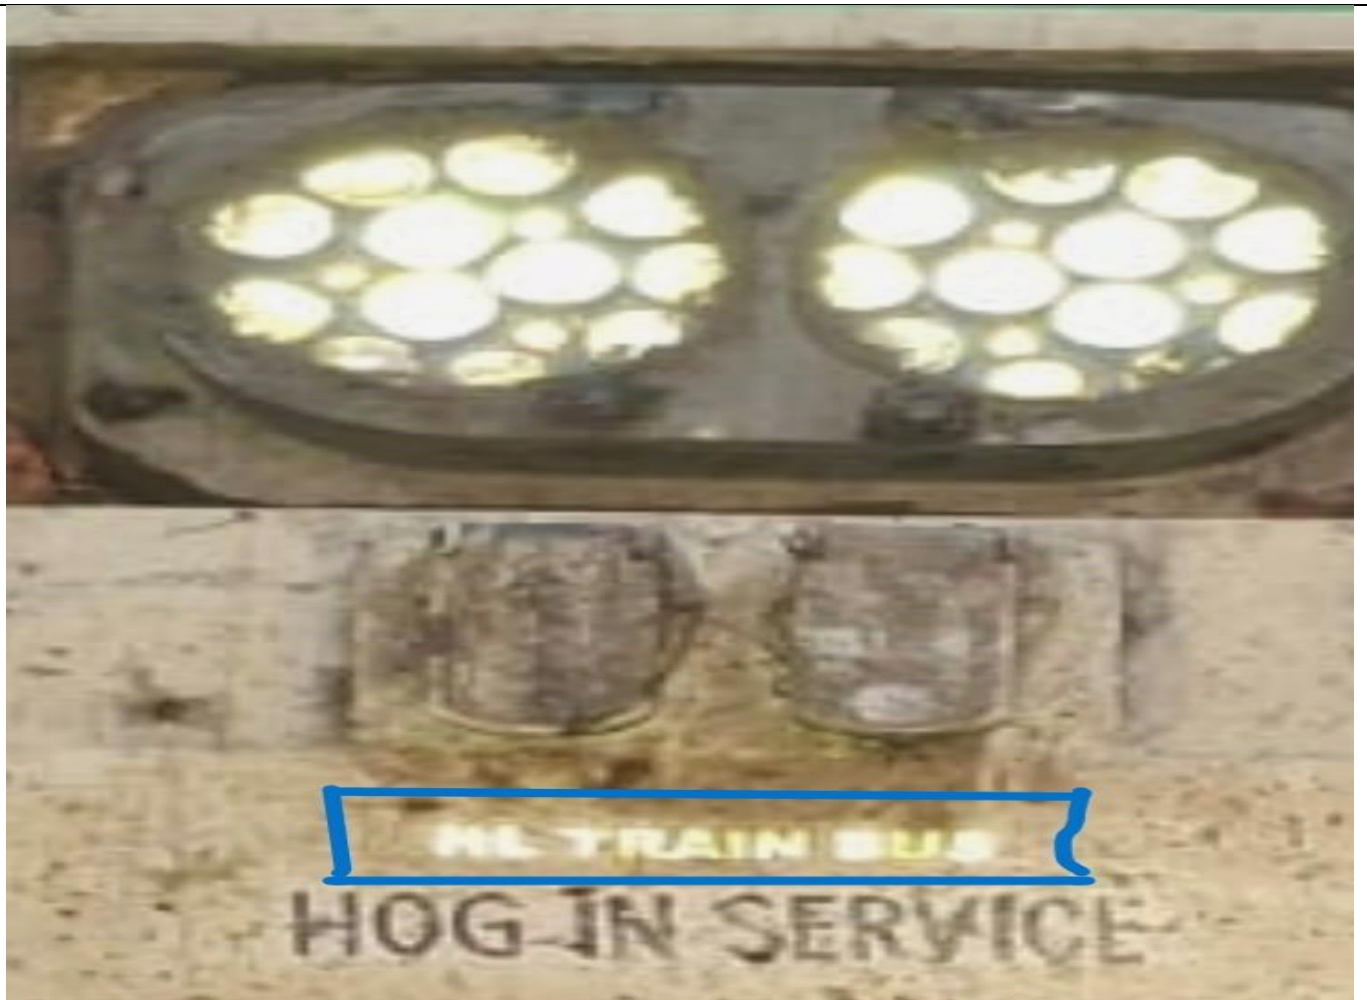
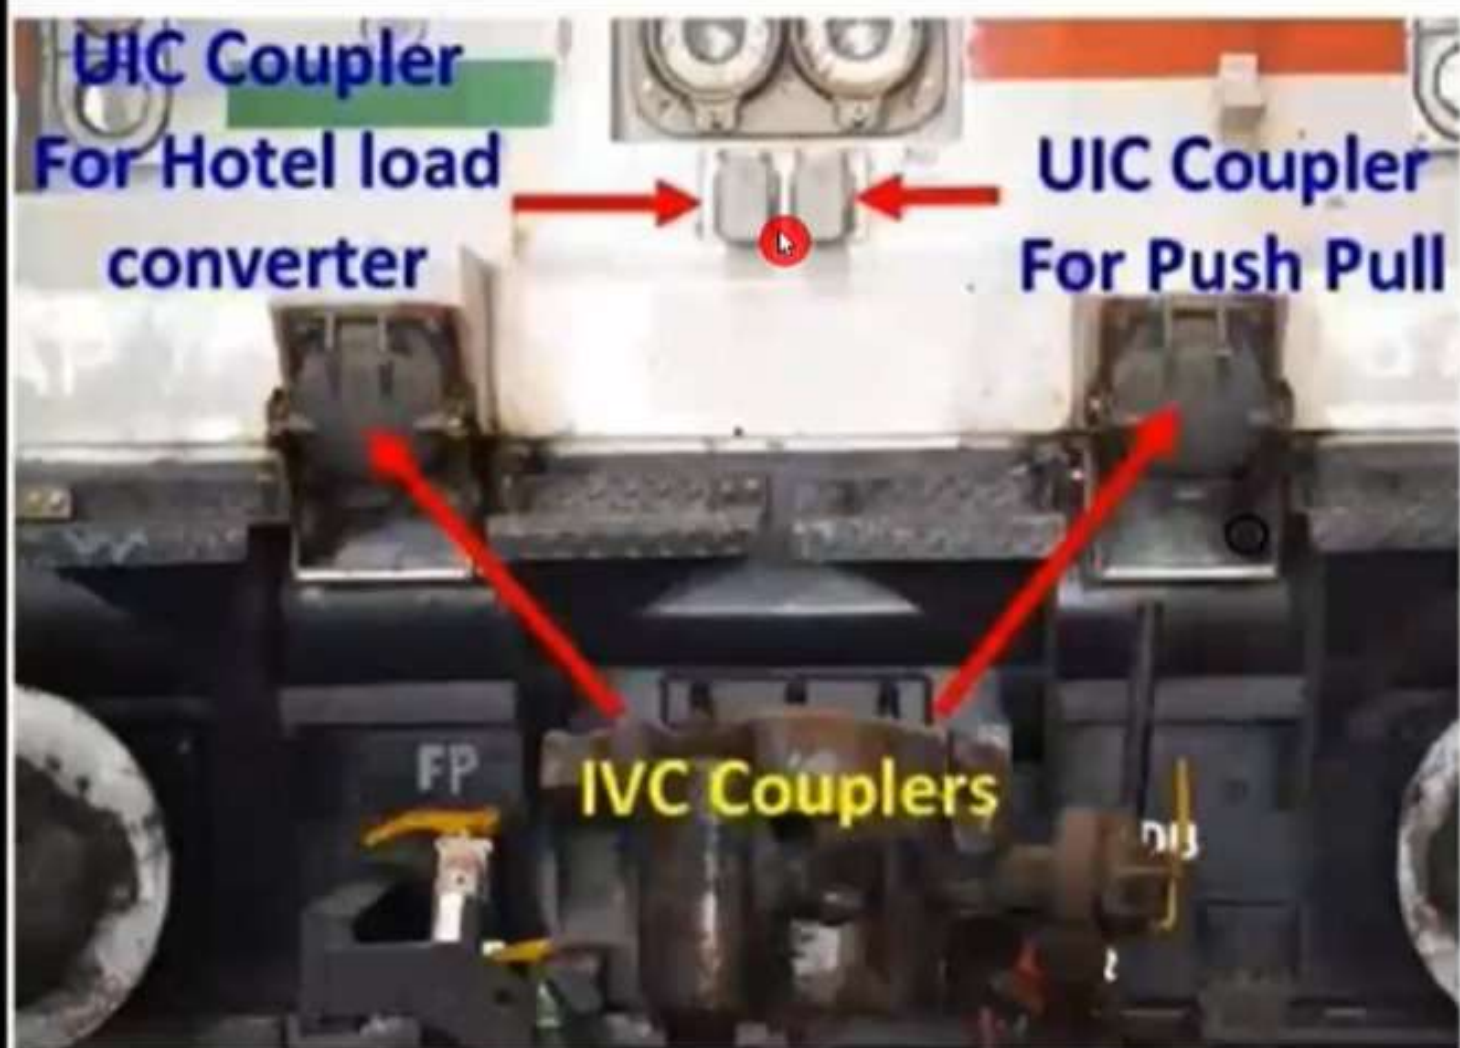
In reference to the above subject, it is submitted that on 29.04.2026 an incident was observed at ASR in train no. 12716, wherein after attachment of the UIC coupler by escorting staff, the working cab failed to complete self-testing and a **“Communication Link Failure”** message was displayed on the DDS.

Subsequently, after detaching one UIC coupler from the train bus slot, the locomotive returned to normal working condition.

It is pertinent to mention that two slots are provided for attachment of the UIC coupler:

- HL Slot (ALP side): Used for control command between locomotive and power car/LSLRD coach.
- Train Bus Slot (LP side): Used for MU or push-pull locomotive operation.

In modified locomotives, both UIC slots are designated for HOG and are marked accordingly. In such cases, both slots can be utilized for control command between locomotive and power car/LSLRD coach.

- While attaching a locomotive to an LHB train, crew must ensure that only one UIC coupler is connected by TL/AC staff in the slot marked as HL or HOG.
- If both slots are marked as HOG in modified locomotives, then both UIC couplers may be connected as required.
